Map & Plan

**North County Industrial Water District No. 1
Water Tower Rehabilitation**

**County of Chautauqua
3 North Erie Street
Mayville, NY 14757
RE: City of Dunkirk
400,000 Gallon Watersphere
June 3, 2011
Brian Purol (716) 753-4804
George Carlson (716) 679-8788
Job No. 311203**

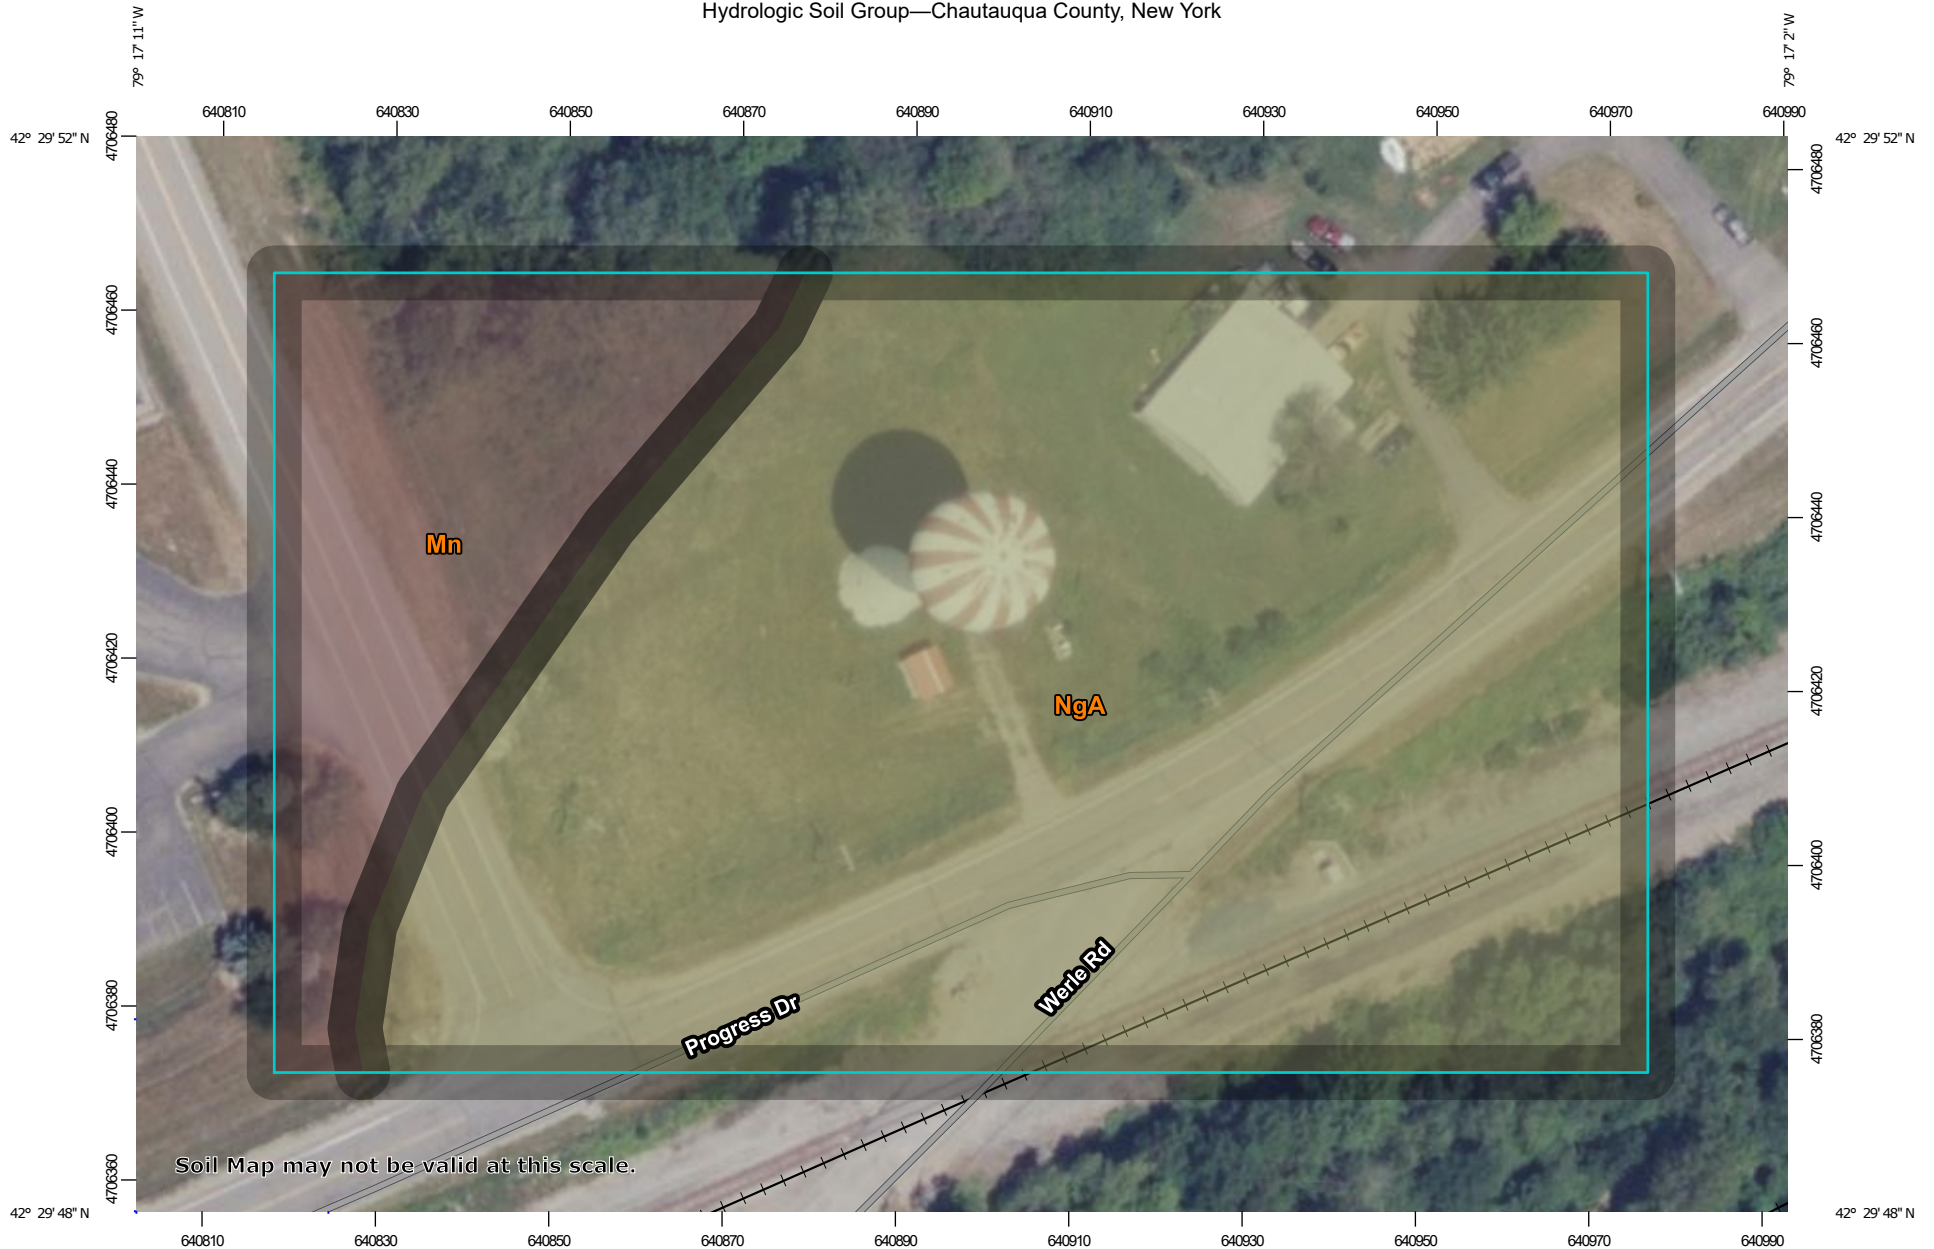
Hydrologic Soil Group—Chautauqua County, New York

Hydrologic soil groups are based on estimates of runoff potential. Soils are assigned to one of four groups according to the rate of water infiltration when the soils are not protected by vegetation, are thoroughly wet, and receive precipitation from long-duration storms.

The current soil type located in the project area is both Minoa fine sandy loam (Mn) and Niagara silt loam (NgA), 0 to 3 percent slopes, loamy substratum. There is no reported bedrock at the site. More information on the geologic conditions can be found in *Appendix B*.

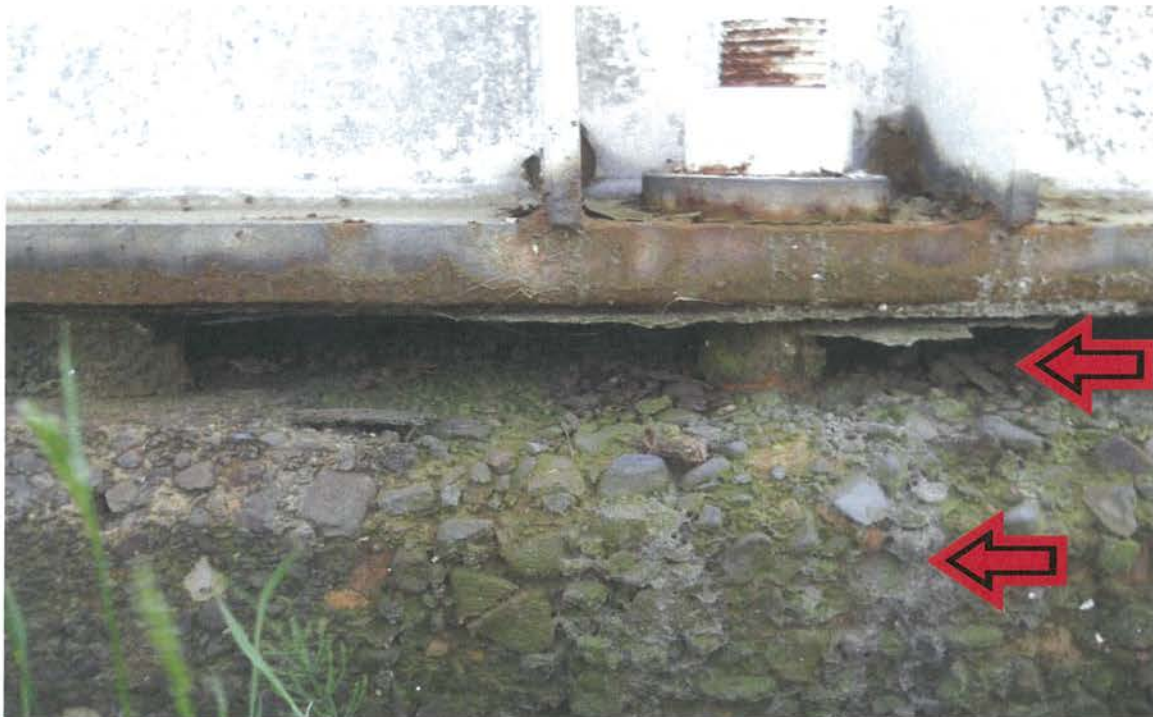
Photo shows the condition of the foundation. We recommend clearing any dirt, debris and other loose gravel away from the tank foundation, down to a minimum 6" below top of foundation as required by AWWA D100-05, Section 12.6.1: Foundations for flat bottom tanks. This should be done by a local excavating company.

We further recommend removing all grout from the baseplate to the foundation connection and regrouting with a commercial nonshrinking grout.

Electrically ground the tank for lightning protection.

2. Remove all grout from the baseplate to the foundation connection and regrout with a commercial nonshrinking grout

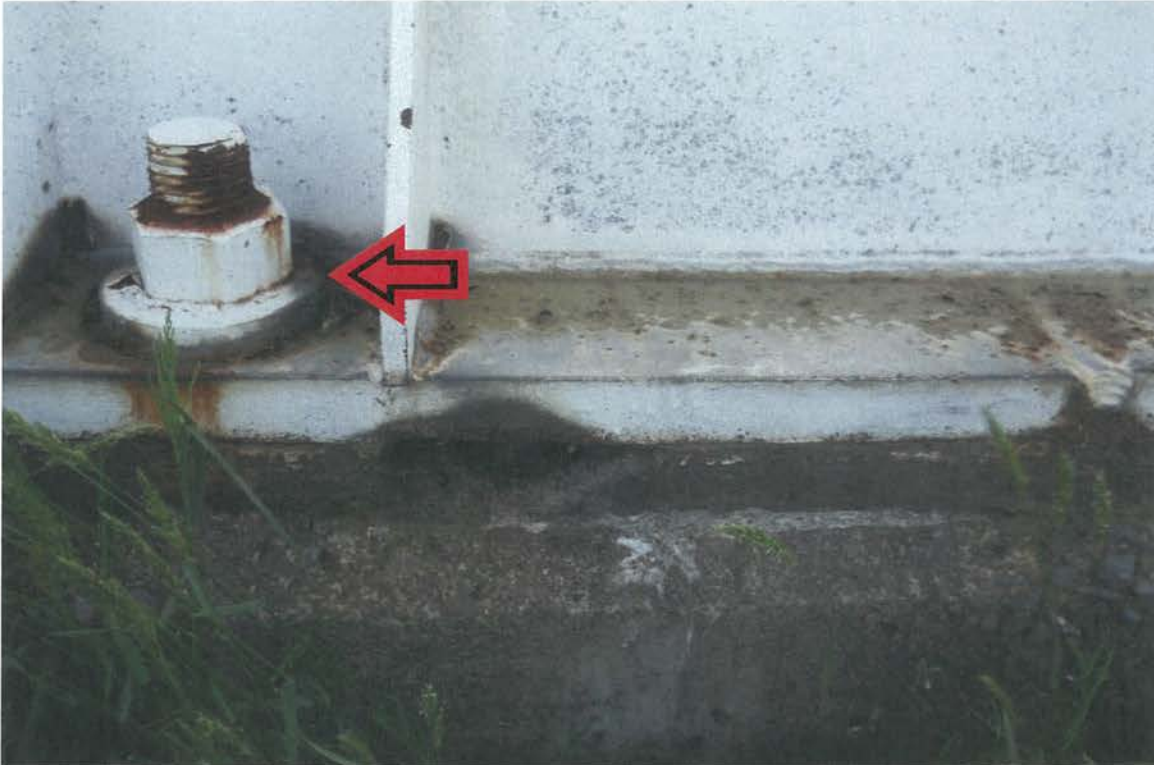
Photo shows the condition of the anchor bolts. The structural integrity of the anchor bolts should be maintained to withstand 100 m.p.h. winds blowing from any direction as required by AWWA D100-05, Section 3.8: We recommend cleaning the area around the anchor bolts, then welding around the circumference of the bolt-to-nut and nut-to-base plate connections to reinforce.

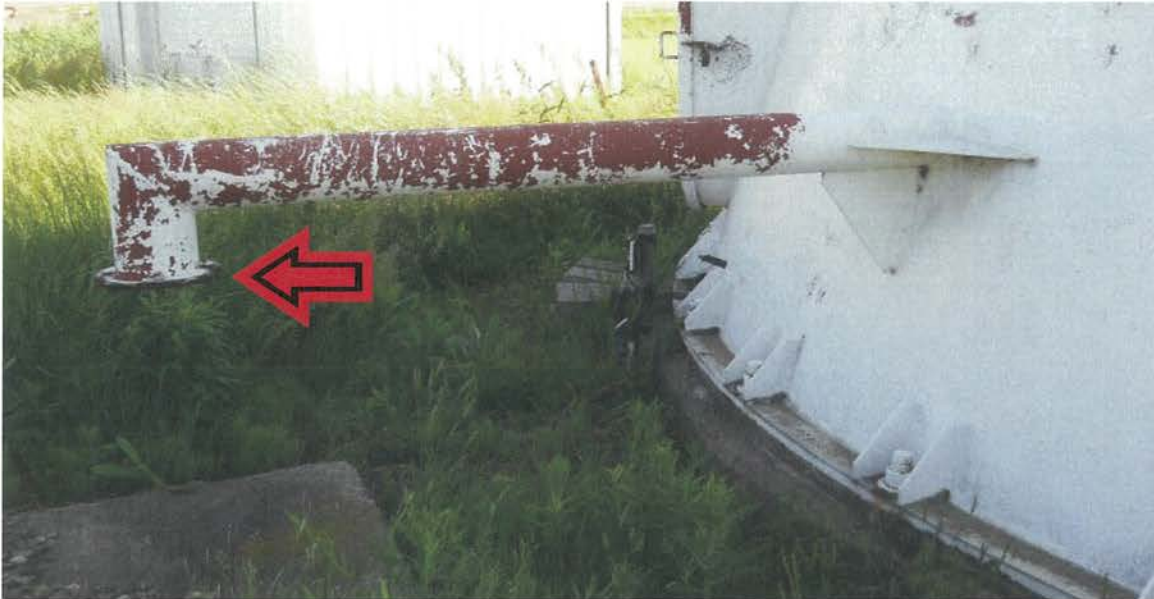
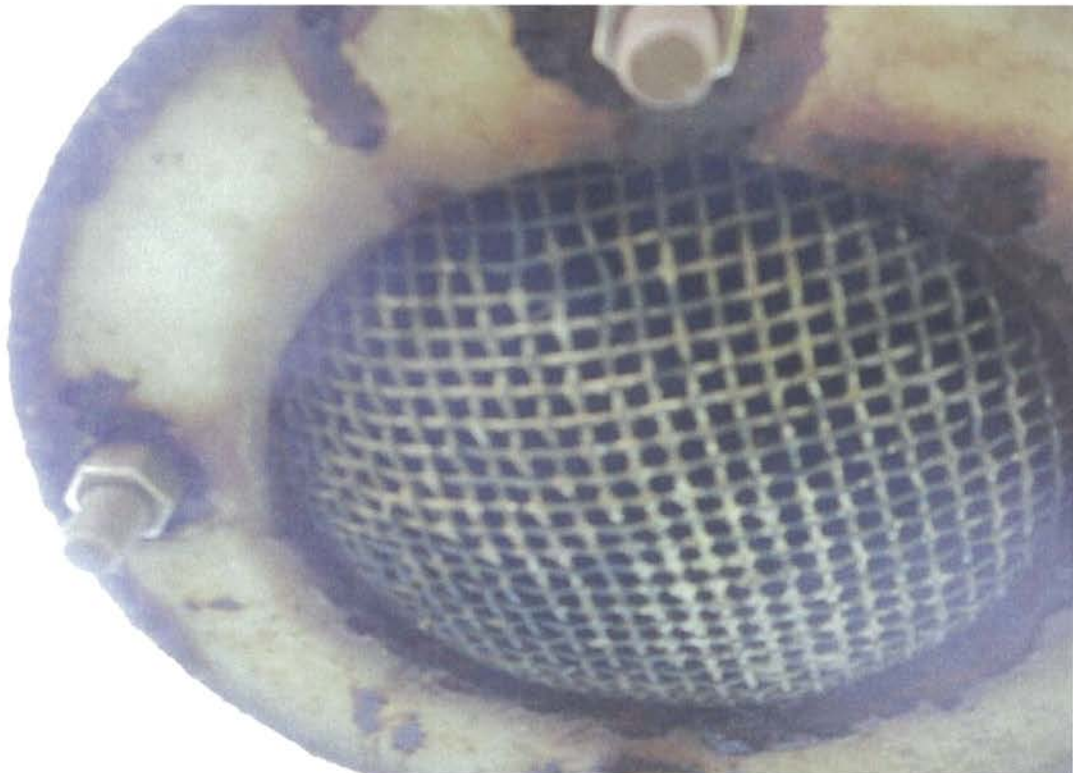
Photos show the condition of the 6" diameter overflow pipe and screen. The overflow pipe is not equipped with a flapper valve, in accordance with AWWA D100-05, Section 7.3: Overflow and TSS. We recommend installing a flapper valve and new screen to prevent the ingress of contaminants into the water supply in accordance with TSS.

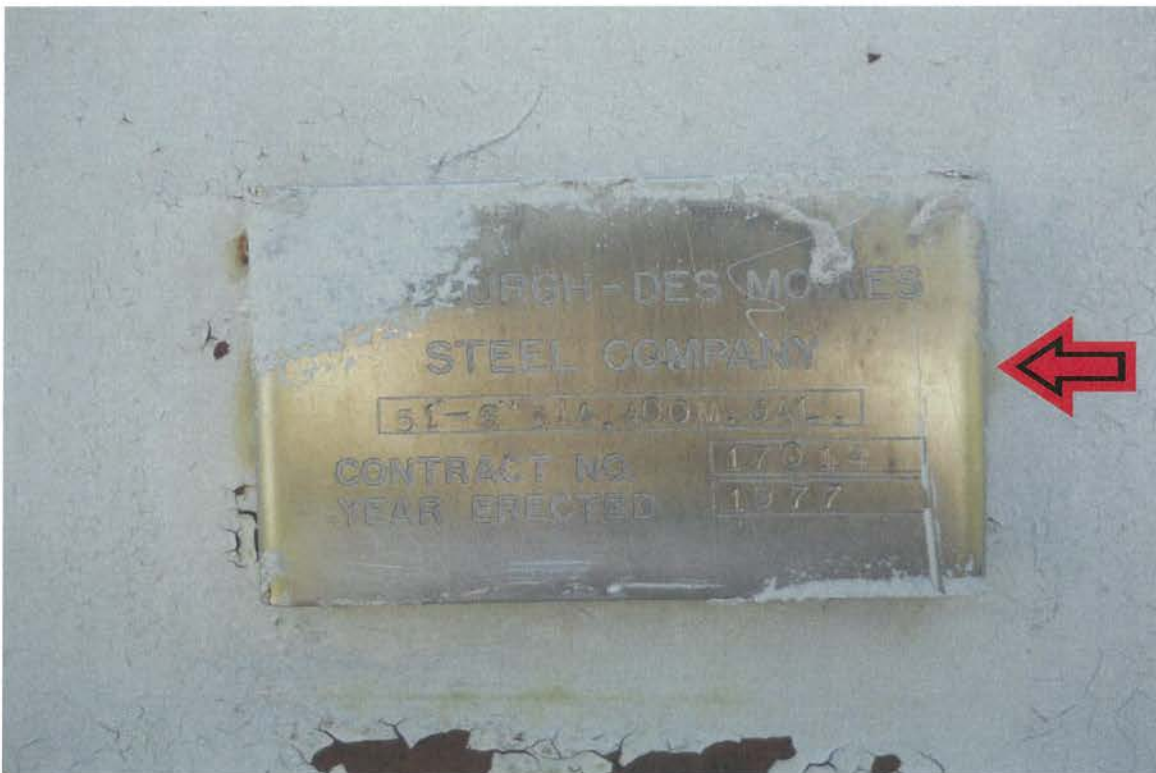
Photo shows the tank name plate. We recommend removing the tank name plate, cleaning the face of the plate, cleaning and repainting the area behind the plate, then remounting it.

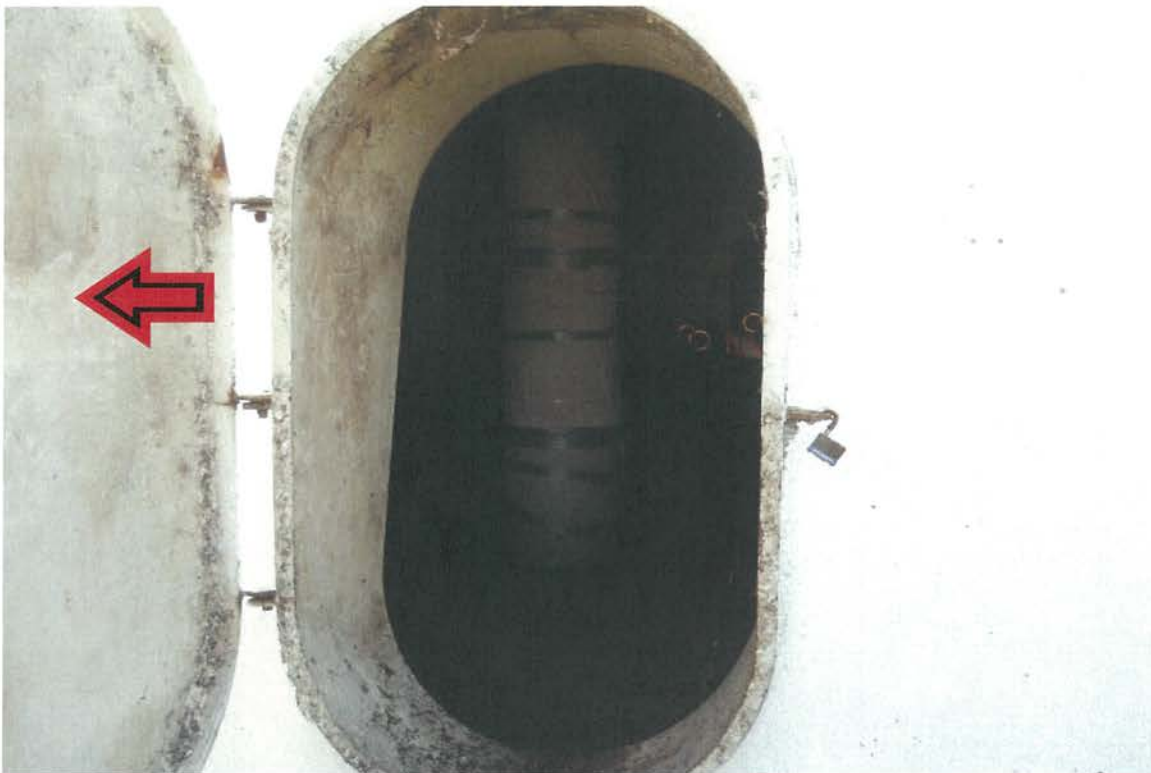
Photo shows the condition basecone door. We recommend posting a **Confined Space Entry** sign as required by OSHA.

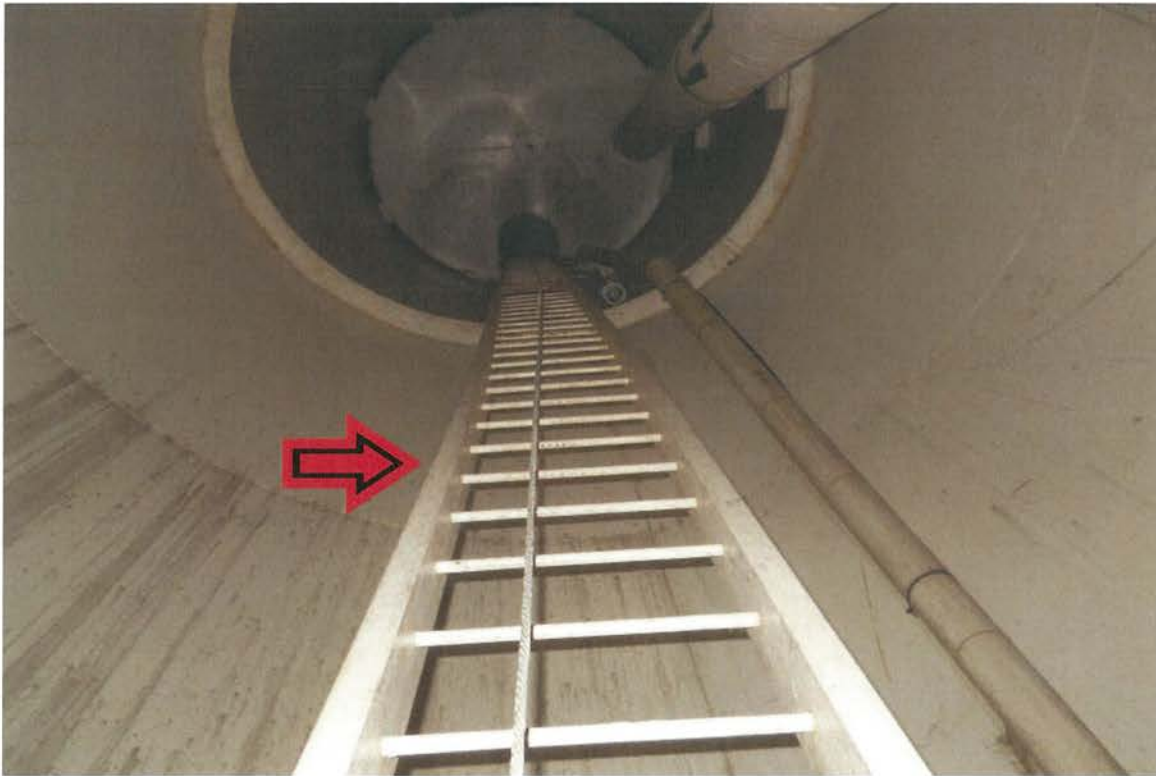
Base cone ladder in above photo is equipped with non-skid rungs and a cable type ladder safety device. All appear to be in good condition. We recommend posting a **Fall Protection Required** sign.

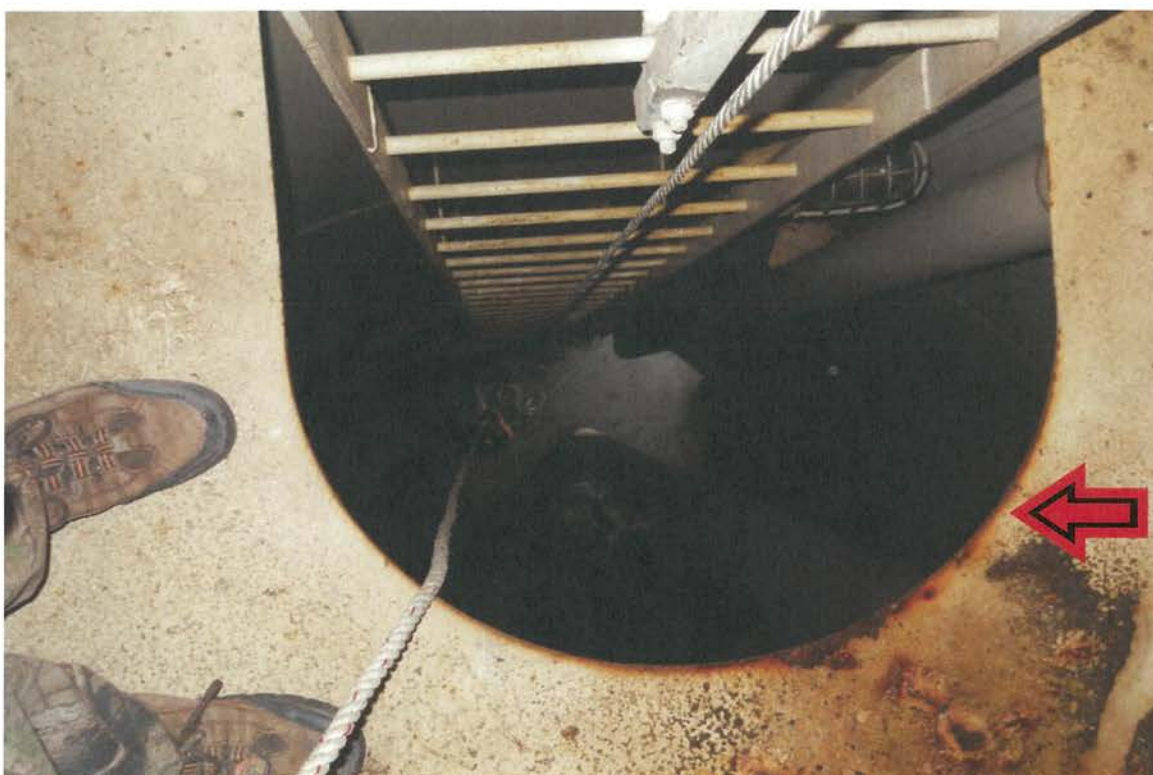
Photo shows the condensate platform, which appears to be in good condition. We recommend installing a drain tied into the overflow pipe and a hinged grating over the opening to prevent a falling hazard.

8. Install a drain tied into the overflow pipe and a hinged grating over the condensate platform opening to prevent a falling hazard.
16. Post **Confined Space Entry** signs
Install handrails around all roof openings
Install new lock on existing manway

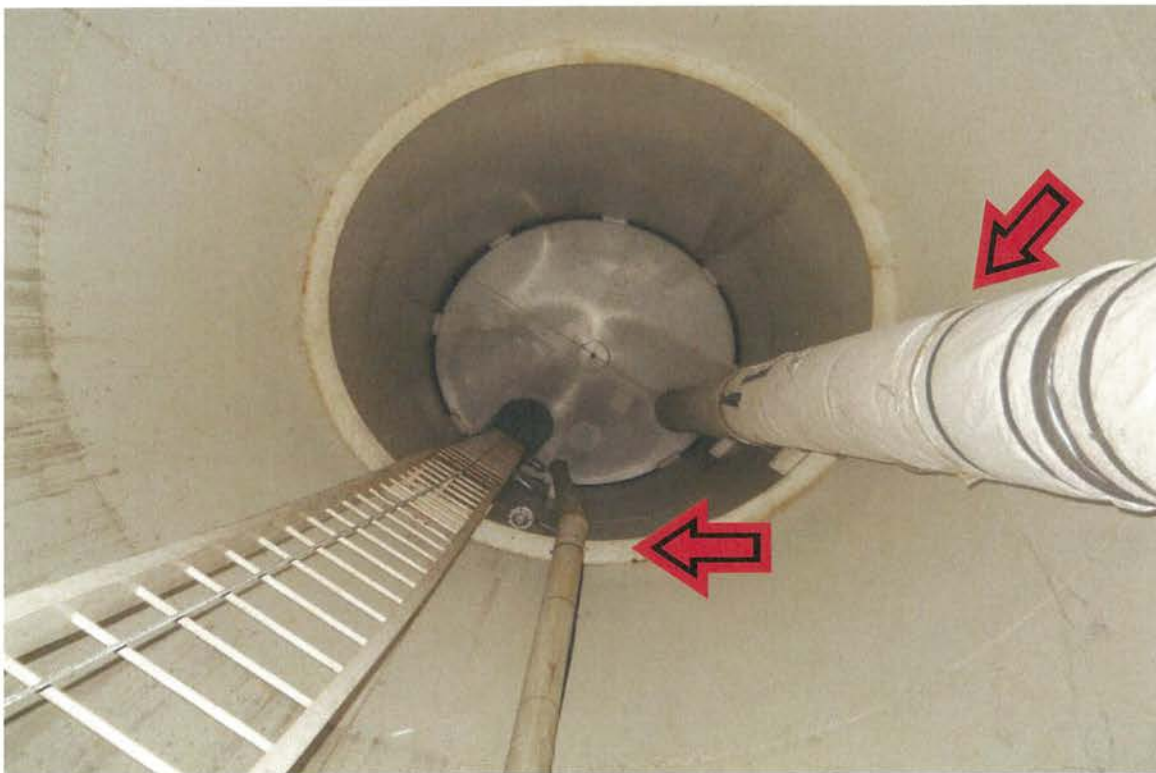
Photo shows the piping insulation which appears to be in adequate condition to prevent pipes from freezing.

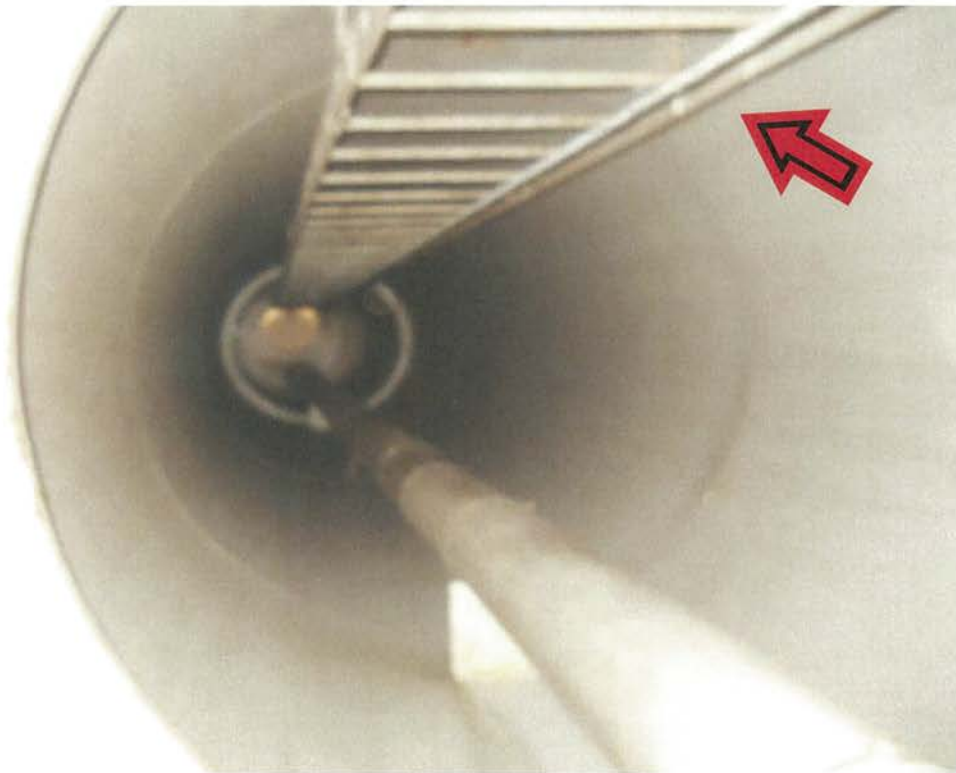
Stem access ladder in above photo is equipped with non-skid rungs and appears to be in good condition.

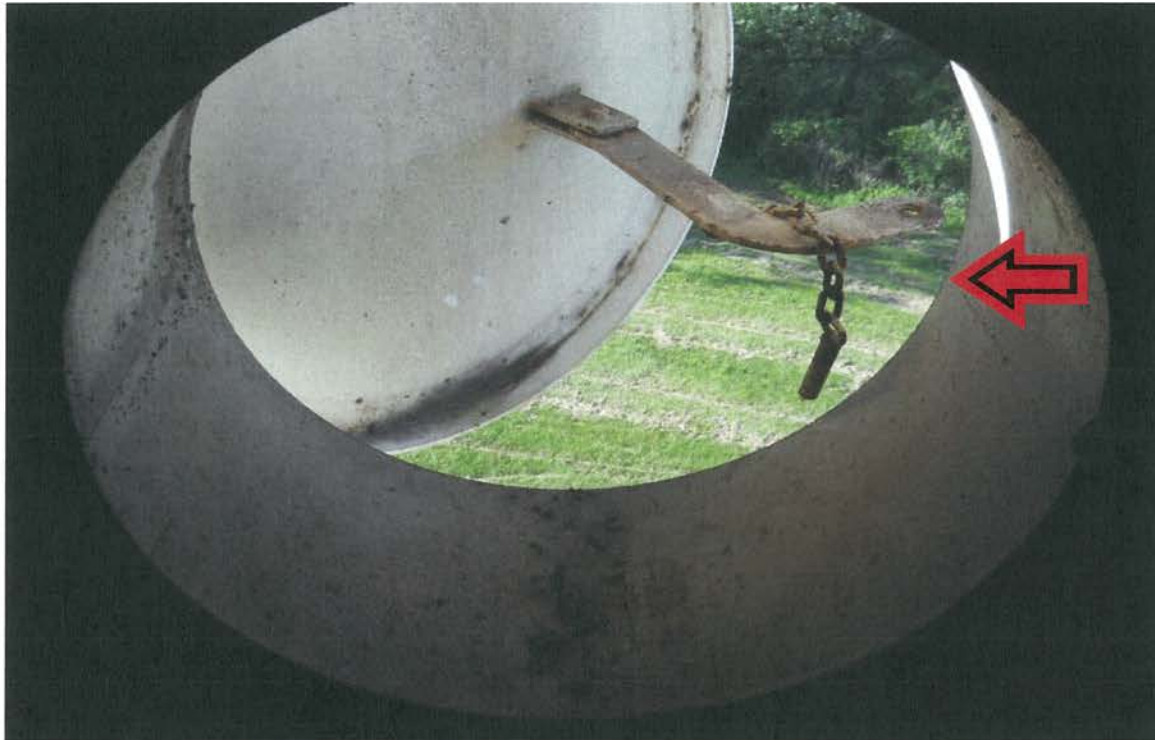
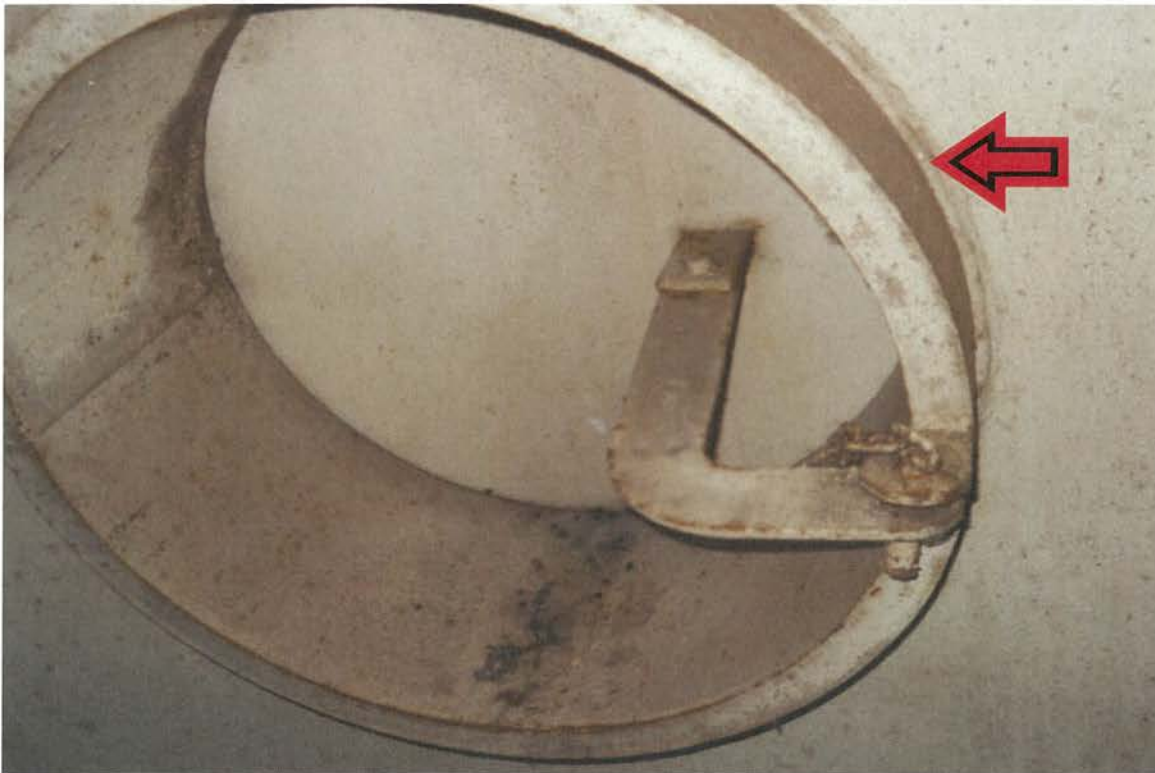
Photos show the painters hatch which appears to be in good condition.

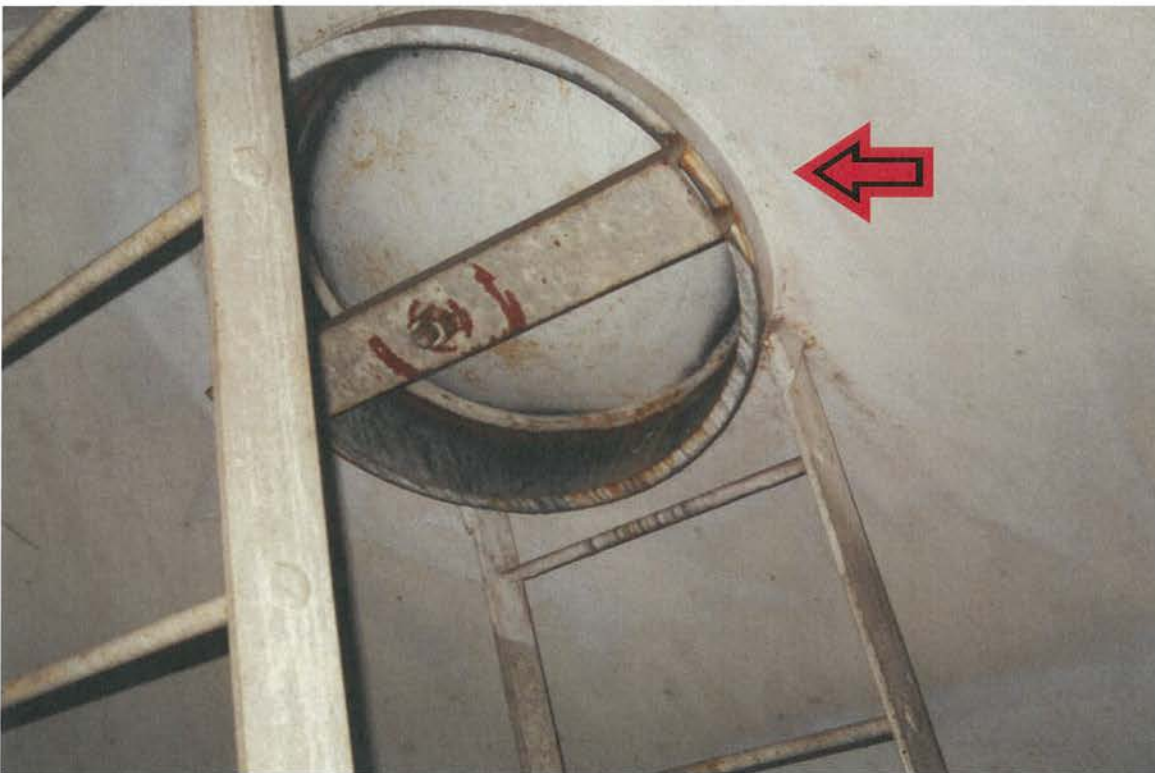
Photo shows the cleanout hatch, which appears to be in good condition.

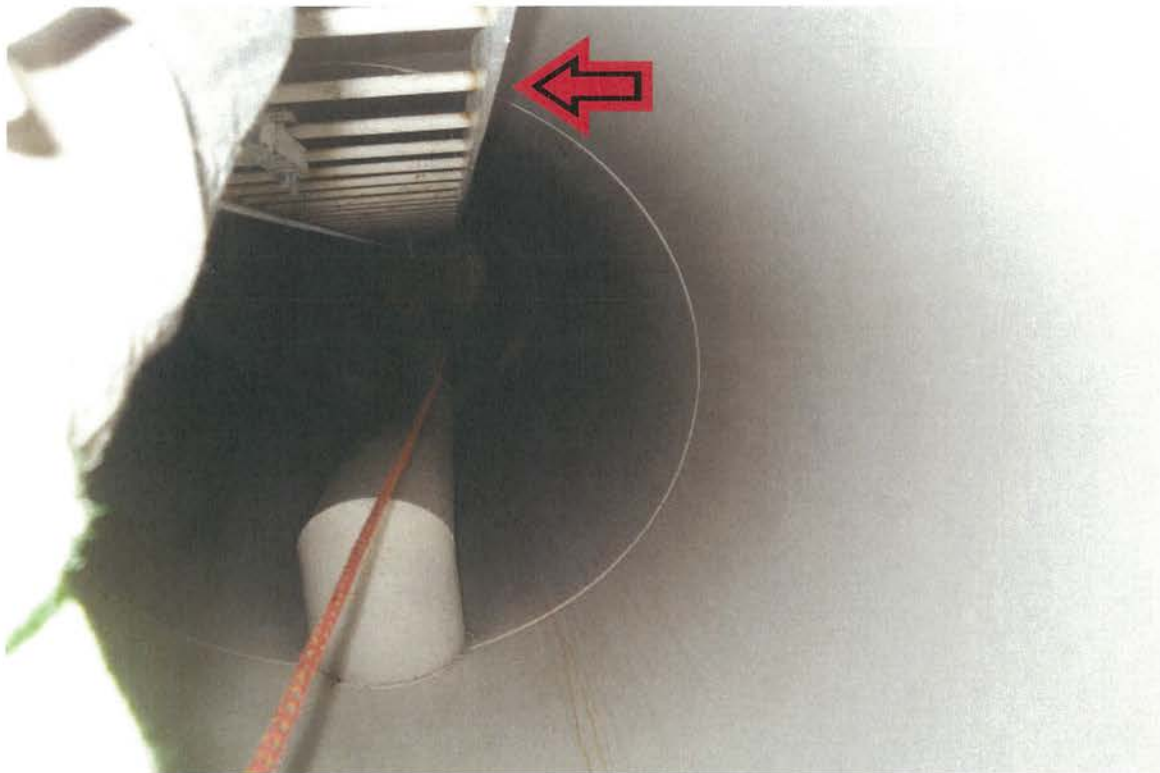
Access tube ladder in above photo is equipped with non-skid rungs and appears to be in good condition.

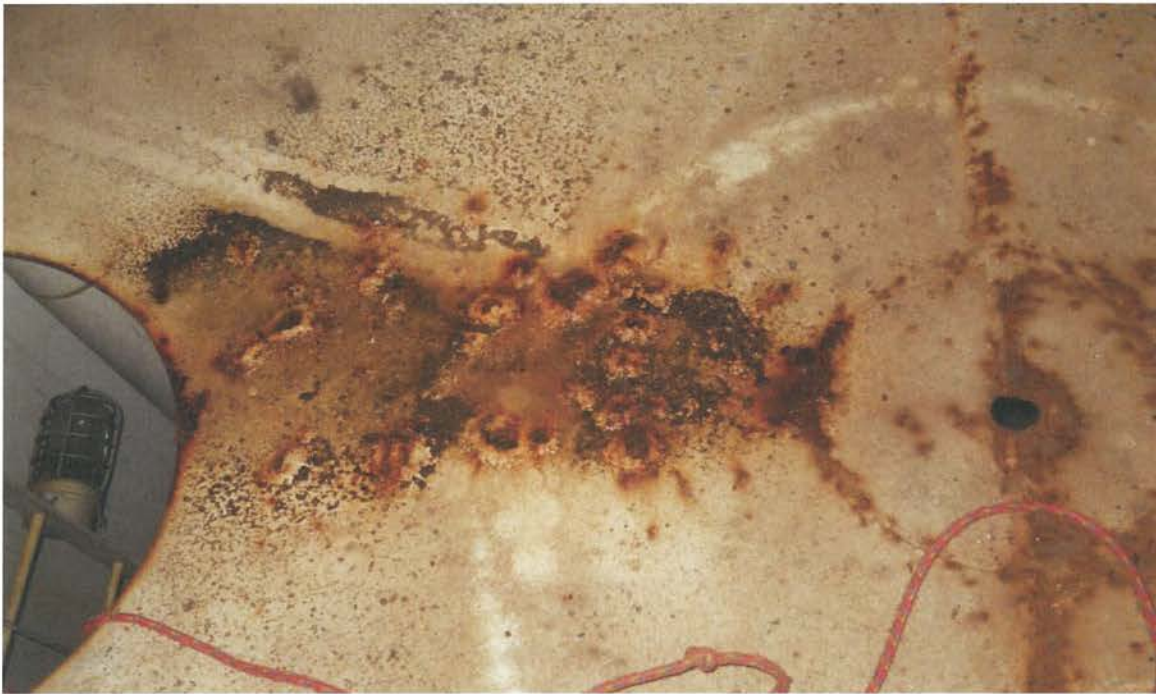
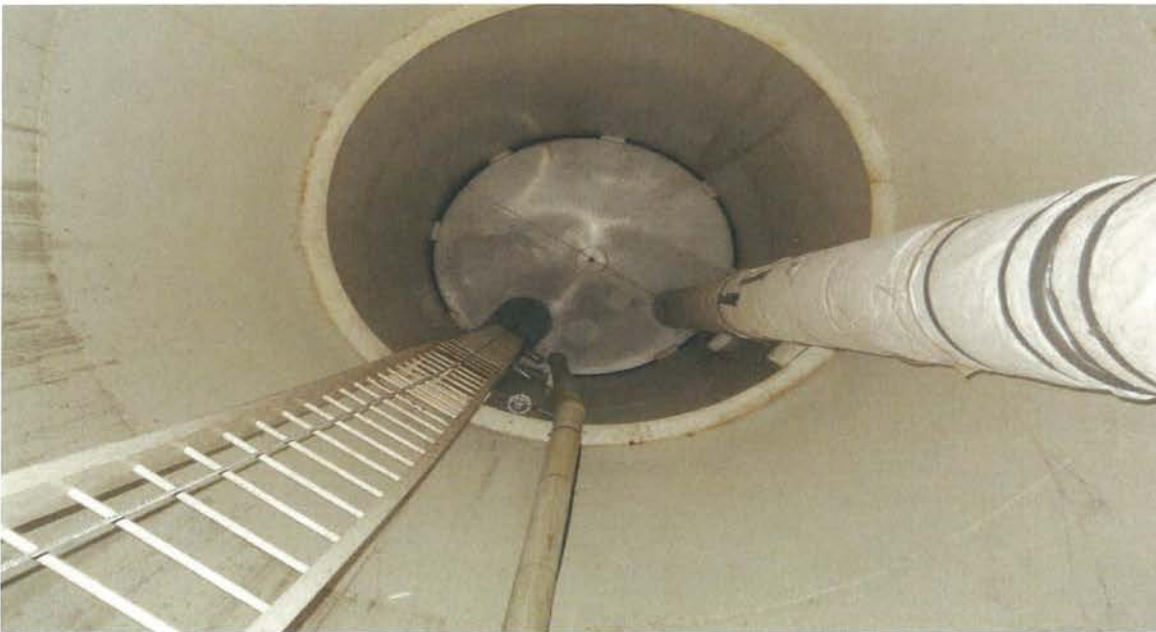
Photos show the tank interior dry area coating system. We recommend pressure washing the tank interior dry area with TSP detergent injection (minimum 3,500 psi at 3.0 gpm) then remove all loose rust and scale with wire brushes and hand scrapers in accordance with SSPC#2 (hand tool cleaning), spot prime and apply one (1) finish coat of alkyd enamel.

14. INTERIOR DRY AREA: Pressure wash the tank interior dry area with (minimum 3,500 psi at 3.0 gpm) then remove all loose rust and scale with wire brushes and hand scrapers in accordance with SSPC#2 (hand tool cleaning), spot prime and apply one (1) finish coat of alkyd enamel

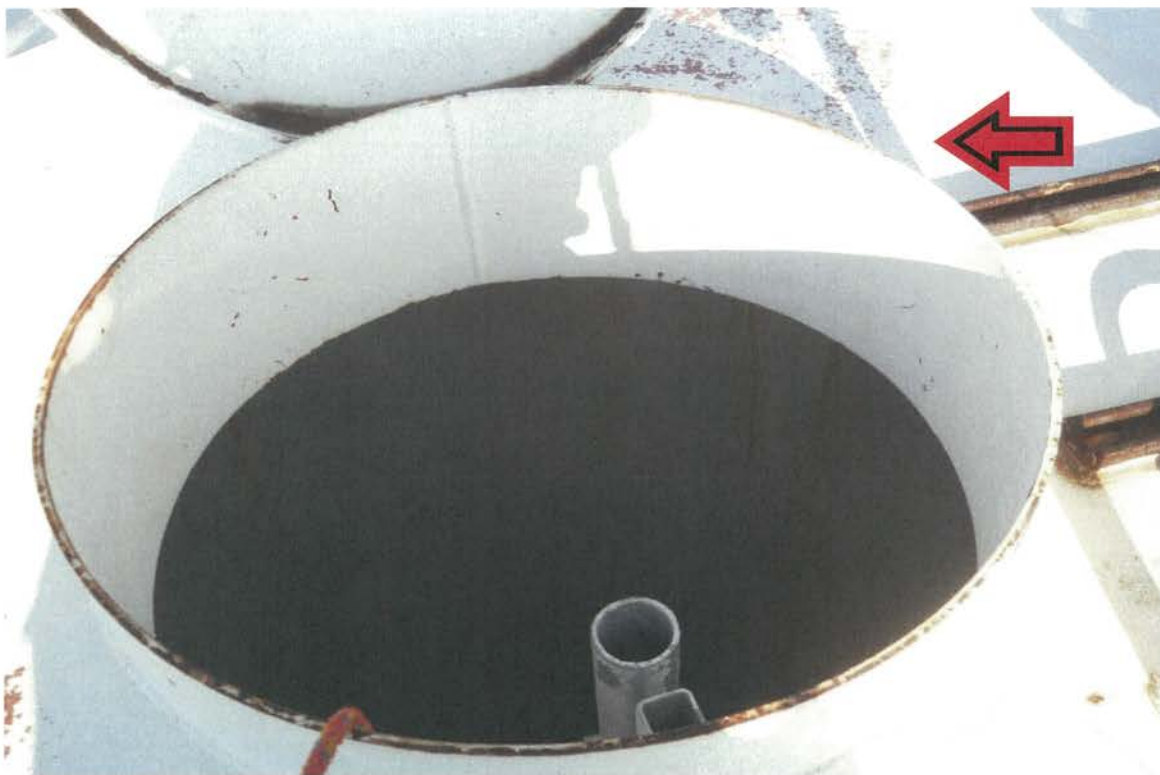
Photo shows the dry riser manway, which appears to be in good condition.

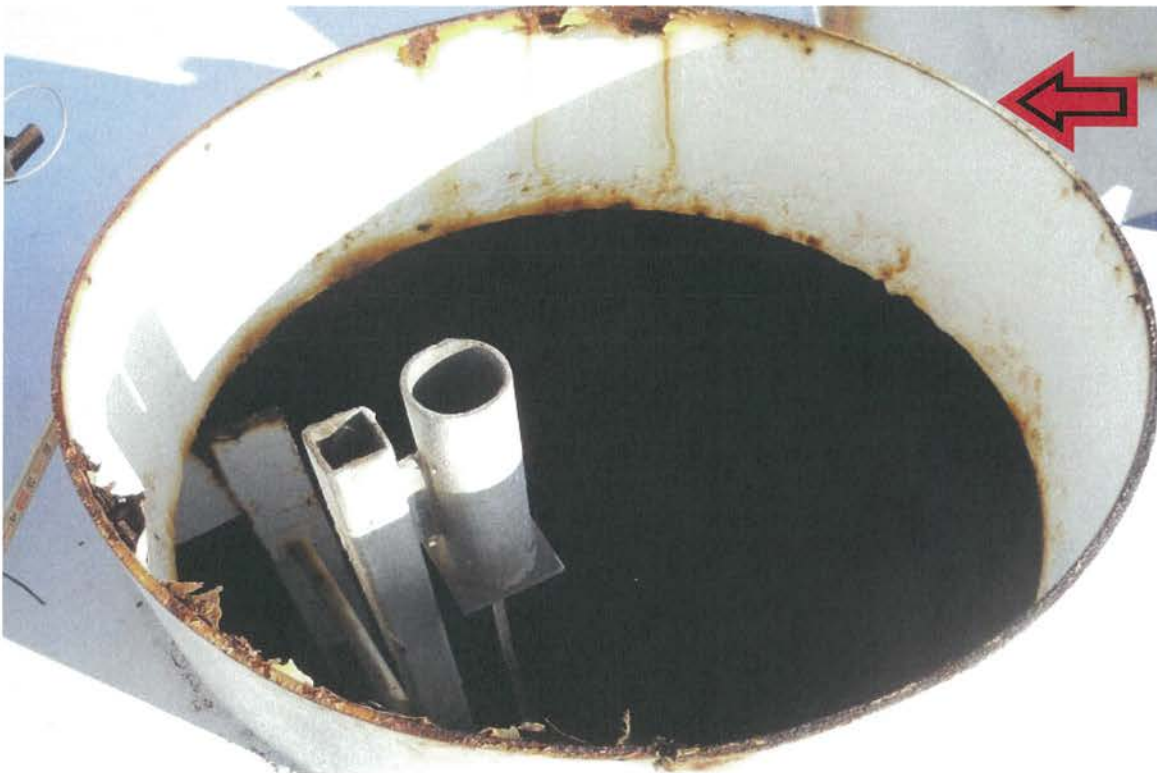
Photo shows the condition of the roof hatch. Roof openings on this tank require the following to be in compliance with OSHA, AWWA D100-05, Section 7.6: Roof openings.

We recommend:

- Post **Confined Space Entry** signs
- Install handrails around all roof openings
- Install new lock on existing roof manway

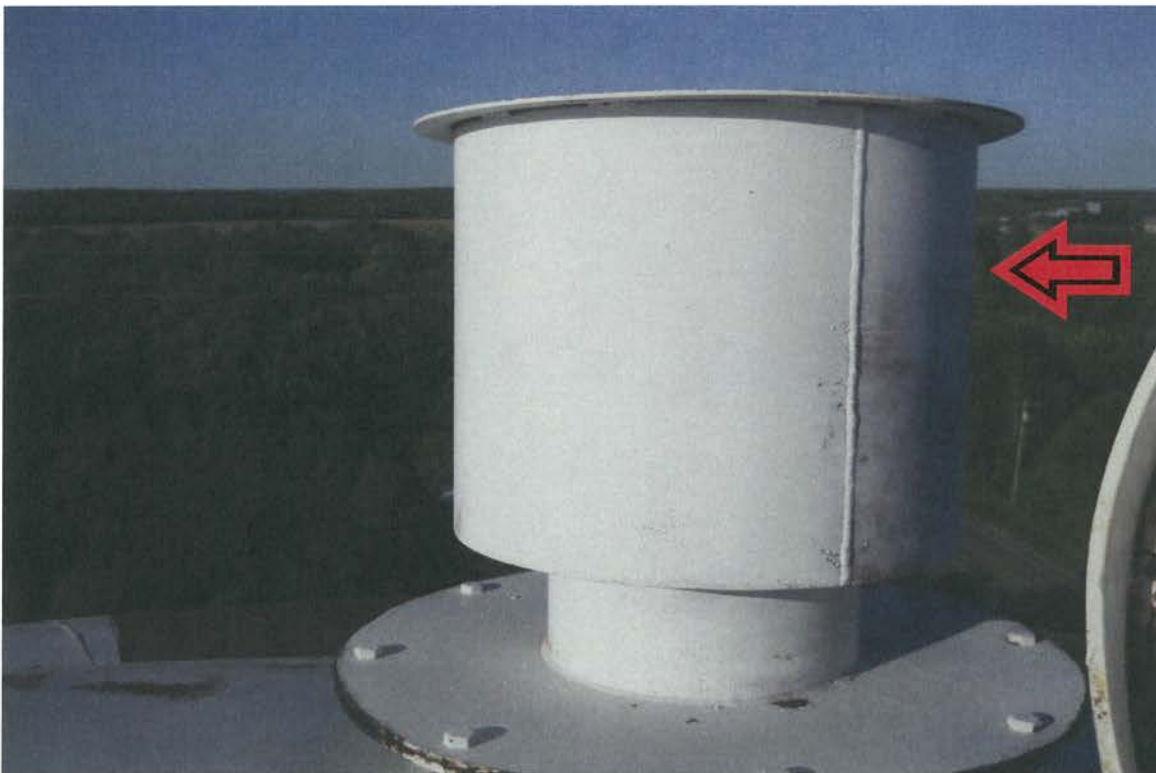
Photo shows the condition of the existing roof vent. **An improperly vented tank may cause external pressure to act on the tank which can cause buckling even at low pressure differential.** We recommend replacing the existing roof vent with a vacuum-pressure, frost proof vent and screen in compliance with AWWA, and TSS.

17. Install a vacuum/pressure, frost proof vent and screen
19. Replace the existing deteriorated interior ladder with an AWWA and OSHA approved interior ladder
Install a new stainless steel ladder safety climb device

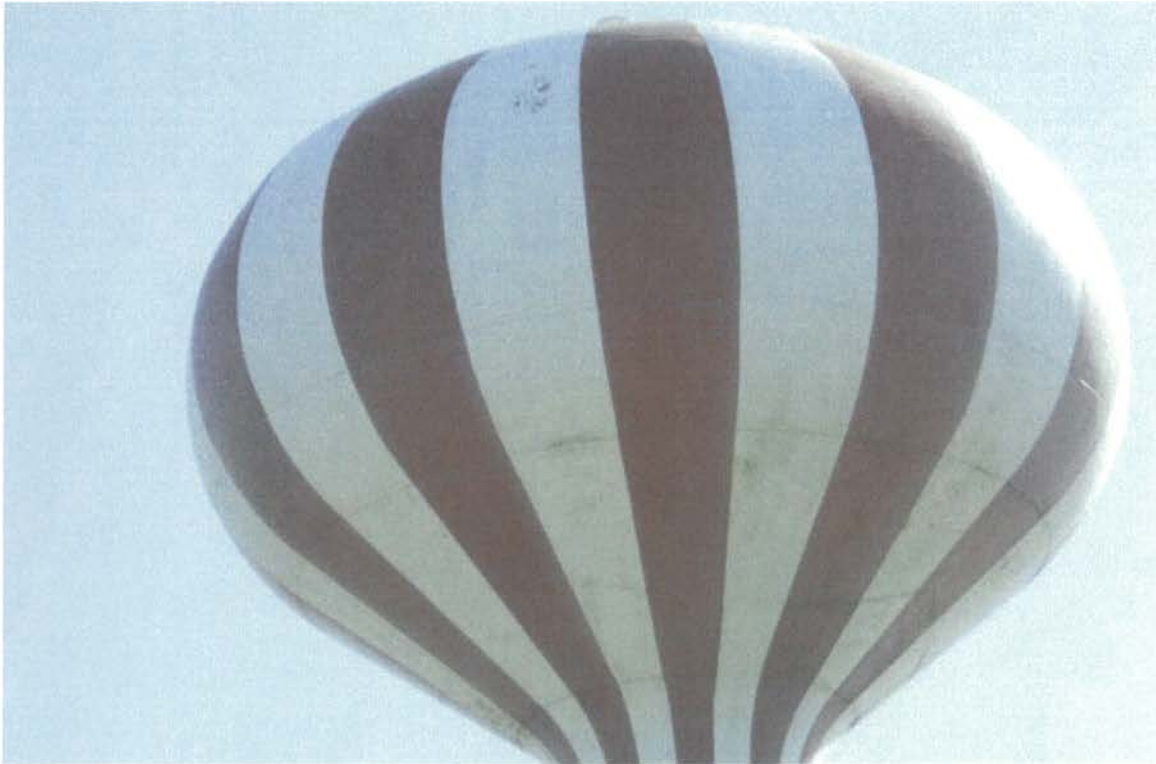
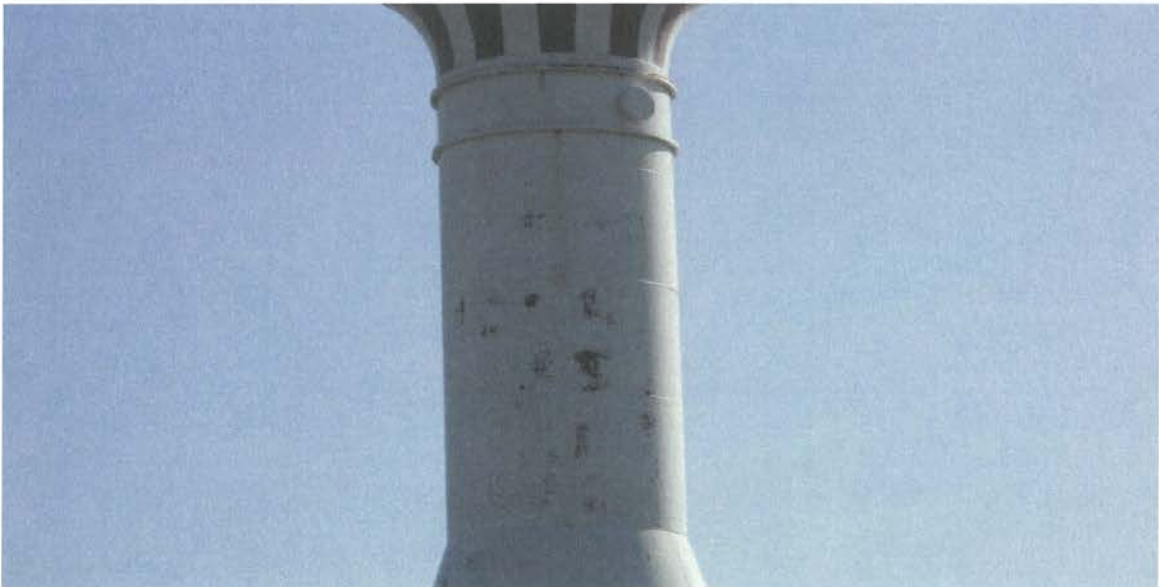
Photos show the tank exterior coating system. We recommend pressure washing the tank exterior with biodegradable detergent injection (minimum 3,500 psi at 3.0 gpm) then remove all loose rust and scale with wire brushes and hand scrapers in accordance with SSPC#2 (hand tool cleaning), spot prime and apply one (1) finish coat of alkyd enamel.

18. EXTERIOR COATING SYSTEM: Pressure wash the tank exterior with bio degradable detergent injection (minimum 3,500 psi at 3.0 gpm) then remove all loose rust and scale with wire brushes and hand scrapers in accordance with SSPC#2 (hand tool cleaning), spot prime and apply one (1) finish coat of alkyd enamel

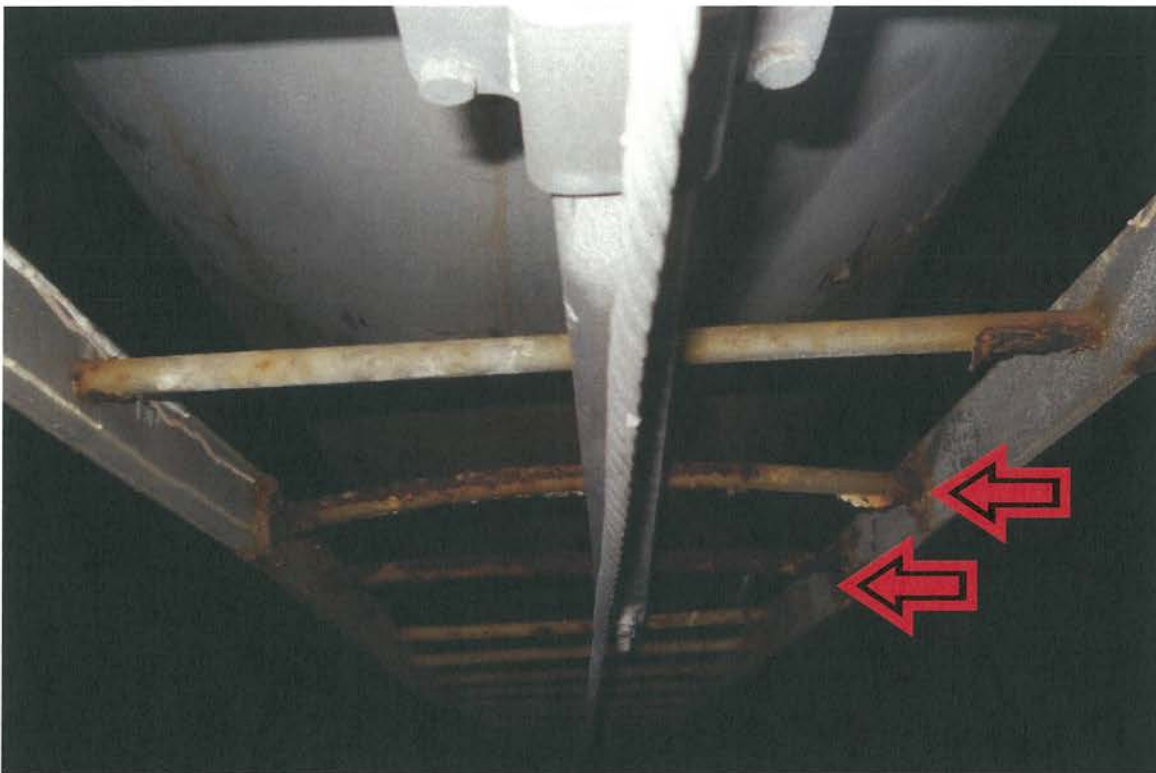
Photo shows the interior ladder is unsafe and in a deteriorated condition. Notice the bent and deteriorated rungs. Use of this ladder may result in injury or death and it should be tagged out of use immediately until it can be replaced. We recommend installing an OSHA approved interior ladder complete with standoffs every 10' on center and a cable type ladder safety device.

These are NFPA/OSHA regulation deficiencies.

For adequate fall protection we have recommended a new cable type fall arrest system.
