Map & Plan

**North County Industrial Water District No. 1
Water Tower Rehabilitation**

**County of Chautauqua
3 North Erie Street
Mayville, NY 14757
RE: City of Dunkirk
400,000 Gallon Watersphere
June 3, 2011
Brian Purol (716) 753-4804
George Carlson (716) 679-8788
Job No. 311203**

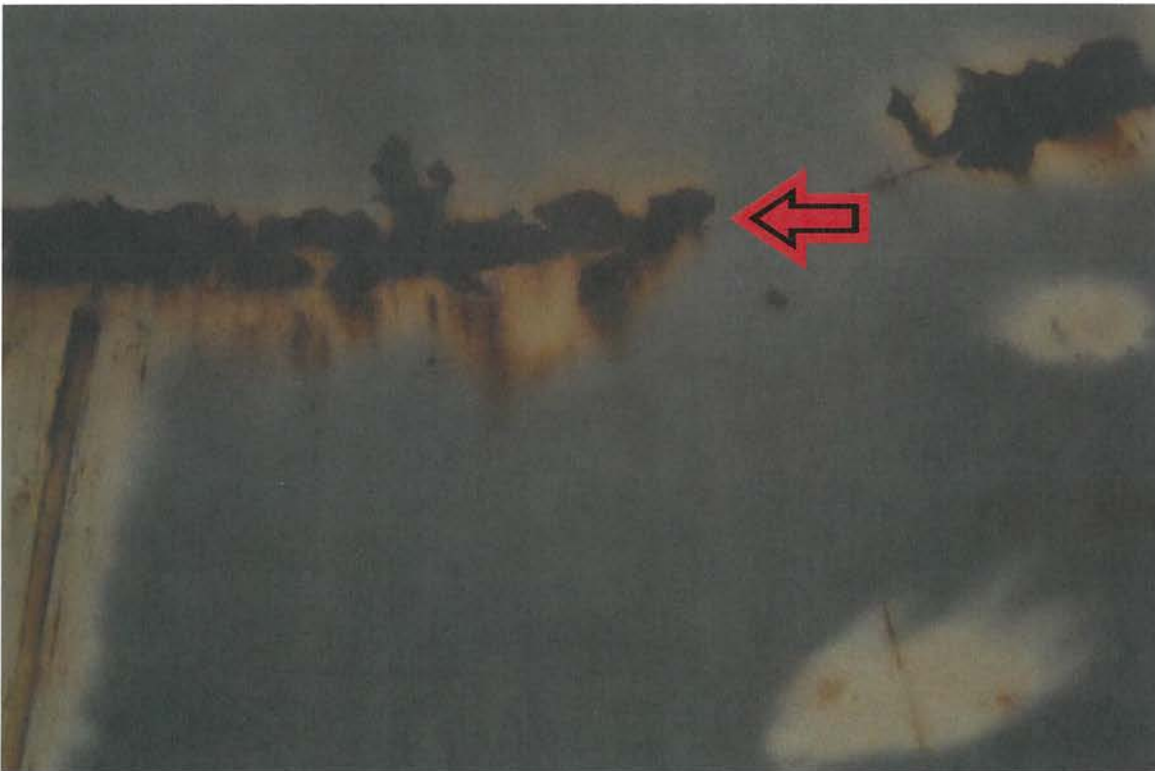
Photo shows the condition of the interior roof. Notice the rust forming at the roof lap seams. We recommend seam sealing using Sika-Flex #1A on all unwelded interior roof lap seams to prevent failure of a new interior liner.

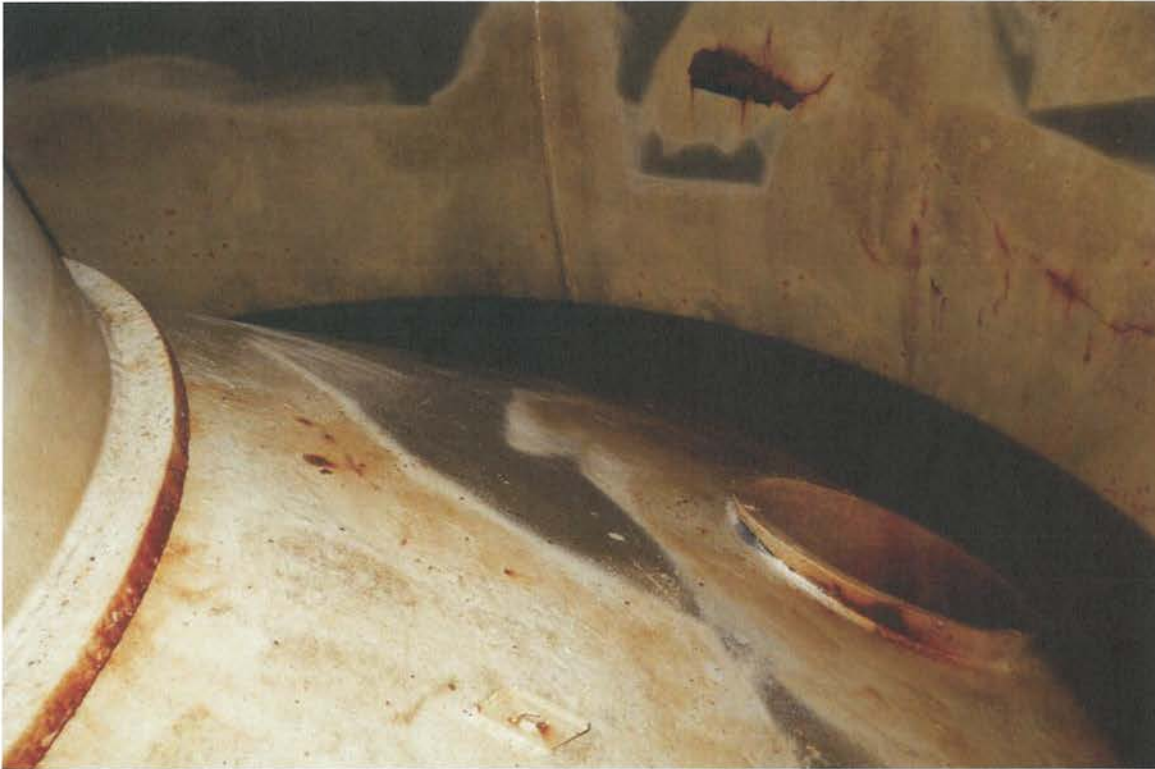
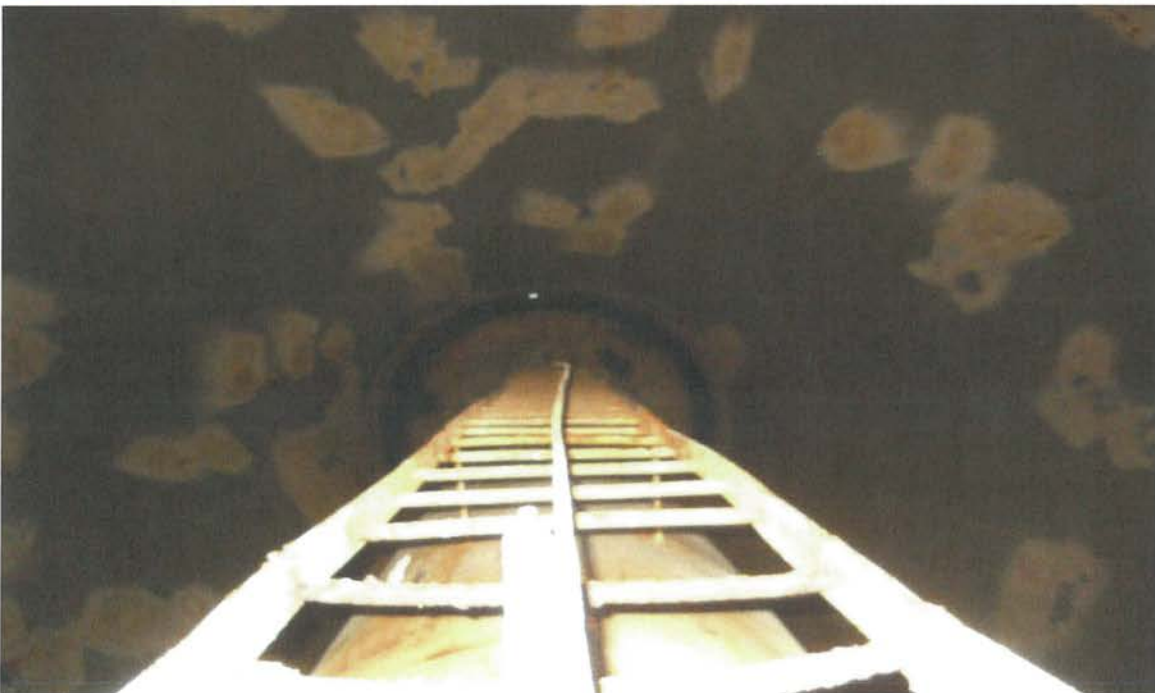
Photos show the tank interior during the cleanout process.

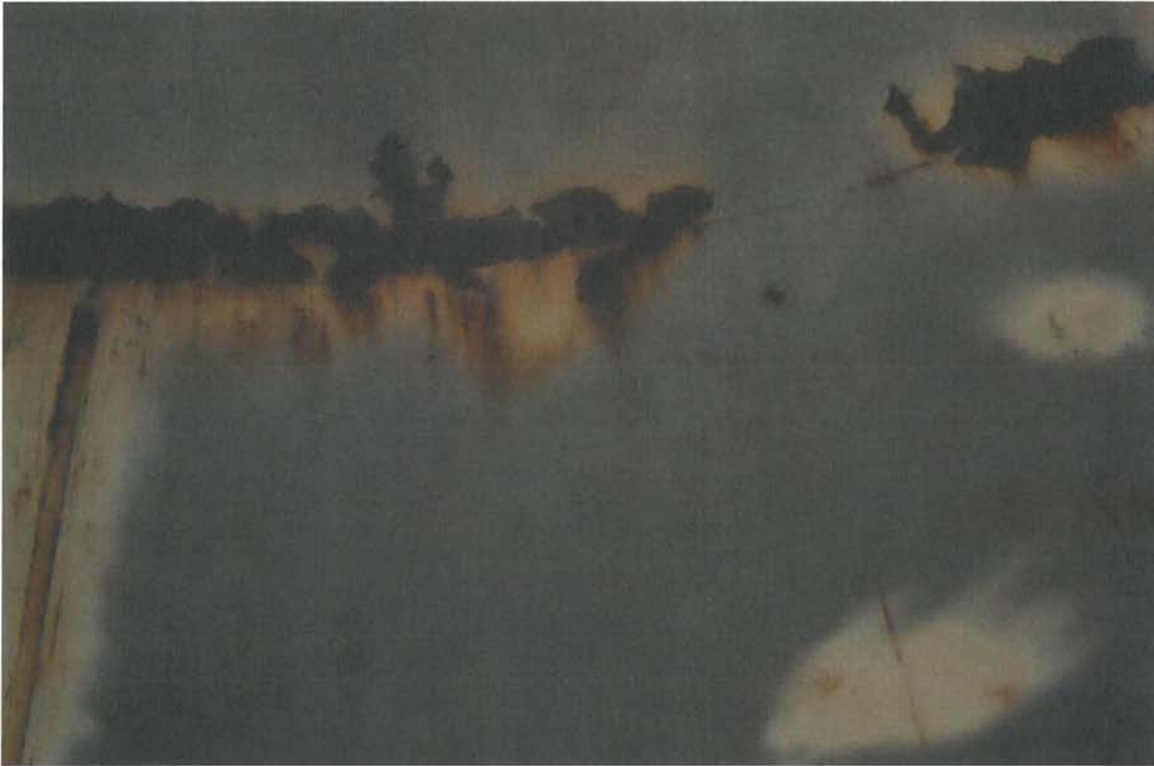
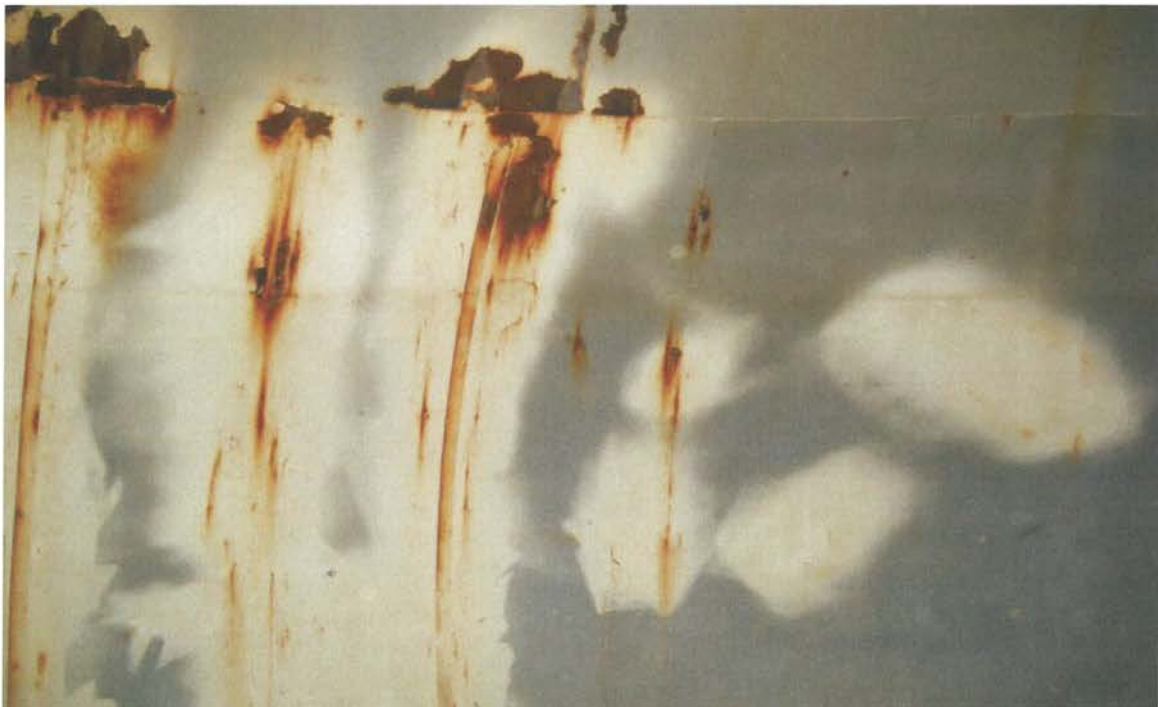
Photos show the condition of the interior liner. We recommend sandblasting all rusted and abraded areas of the tank interior to an SSPC #10 (near white blast) condition, brushblast all remaining areas, stripe coating all seams and welds, then applying an epoxy liner to achieve 8-10 mils of dry film thickness.

22. INTERIOR COATING SYSTEM: Sandblast all rusted and abraded areas of the tank interior to an SSPC #10 (near white blast) condition, brushblast all remaining areas, stripe coating all seams and welds, then applying an epoxy liner to achieve 8-10 mils of dry film thickness.
