Selected 2% Occupancy Tax Grant Project Summaries

Created By Jeff Diers – June 21, 2013

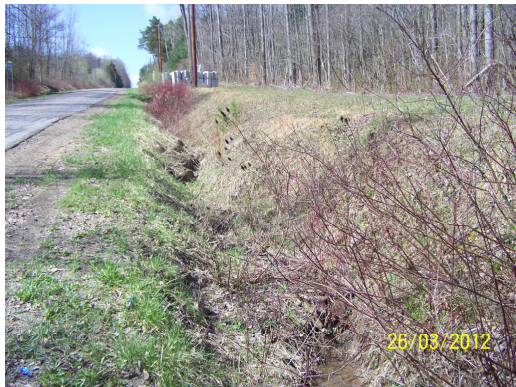
The Bly Hill Road drainage ditch system flowing to Chautauqua Lake had severe erosion problems from stormwater due to steep gradients that produced significant water volume and velocities, leading to increased bed and bank erosion. This elevated sediment and nutrient load flowed directly to the Lake. In order to reduce the on-site erosion, the Town of North Harmony installed concrete deadman drops along a 460 linear foot stretch along the north side of Bly Hill Road. These deadman drops reduced the slope of the ditch channel from a 12% gradient to approximately a 2% gradient. As such, the velocity of the stormwater runoff was reduced as well as the potential for channel erosion, thereby stabilizing the ditch and allowing for healthy vegetative cover to be re-established. The work completed was designed to provide a long term remedy to sediment and nutrient loading to the Lake.

Photo 1: Bly Hill pre-ditch stabilization

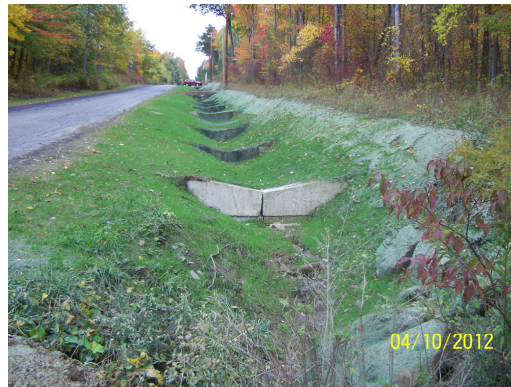
Photo 2: Bly Hill post-ditch stabilization

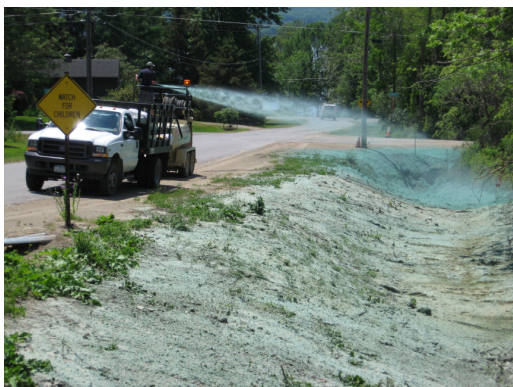
The primary objective of this project was to substantially control erosion and sediment transport from ditches as recommended in the *Chautauqua Lake Watershed Management Plan*. The Chautauqua County Soil & Water Conservation District provided hydro-seeding to villages, towns and county highway departments across Chautauqua County immediately after ditching projects. The re-establishment of vegetative growth in the road ditch will improve water quality before entering Chautauqua Lake.

Photo 3: Hydro-seeding application

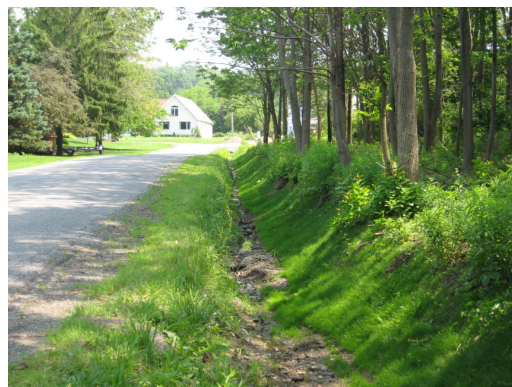
Photo 4: Post hydro-seeding application

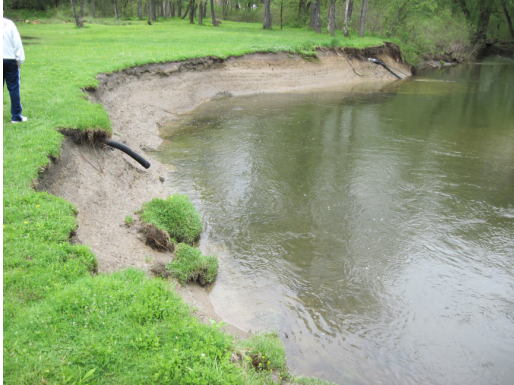
A section of streambank along Goose Creek was in a constant state of severe erosion, leading to significant sediment and nutrient loading to Chautauqua Lake. Chautauqua County Soil & Water Conservation District installed rock-rip-rap, and with the help of Hewes BOCES Environmental Science students, planted willow trees to further stabilize the streambank. The work completed was designed to provide a long term remedy to sediment and nutrient loading to the Lake.

Photo 5: Pre-streambank stabilization

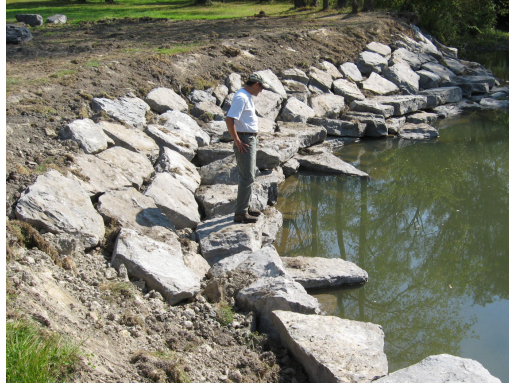
Photo 6: Post streambank stabilization

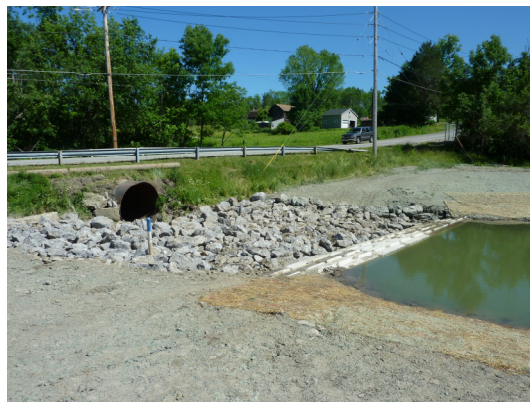
The site located on Shadyside Road in the Town of Busti was identified in the *Chautauqua Lake and Watershed Pre-Implementation Studies Report* as a priority site due to excess sediment and nutrient loading from entering the stream at locations upstream. To address the sediment and nutrient loading, a debris basin and constructed wetland were installed. The debris basin allows for catching and storing of sediments and waterborne debris, while the marsh/wetland adjacent to the site provides an additional method for sediment and nutrient removal. The work completed was designed to provide a long term remedy to improve water quality by reducing sediment and nutrient loading to the Lake.

Photo 7: Post installation of debris basin and constructed wetland

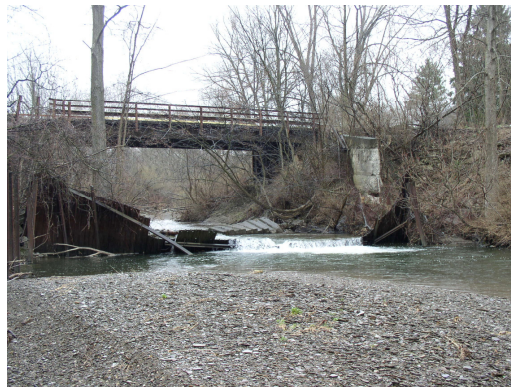
The weir located at 5644 Meadows Rd, on Dewittville Creek is in danger of collapsing, which would release tons of sediment downstream and would destabilize the adjacent bridge supports. In order to save the weir and bridge, the Chautauqua County Soil & Water Conservation District will install grade stabilizers and limestone rip-rap. The project will be specifically designed to provide a high level of treatment to prevent pollutant loads, in this case, sediment from eroding the streambed prior to discharge into Chautauqua Lake. The present weir has been in place many years, preventing the streambed from degrading and eroding sediments downstream. Using limestone rocks to stabilize the weir from collapse, this project provides for a long term level of treatment.

Photo 8: Pre- weir and grade stabilization

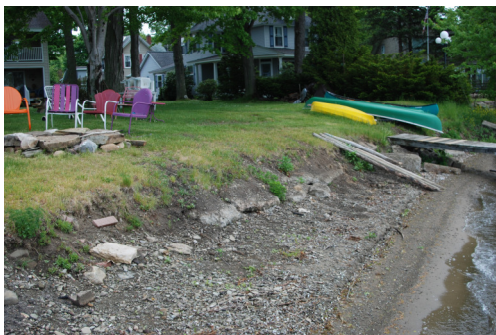
Approximately 650 feet of Chautauqua Lake (Maple Springs) was under constant degradation, primarily from wind-driven wave and ice erosion. This results in eroded sediments and nutrients being deposited to the Lake. In order to stabilize the shoreline and prevent sediment and nutrient loading to the Lake, rock-rip-rap and willow trees were installed. The work completed was designed to provide a long term remedy to sediment and nutrient loading to the Lake.

Photo 9: Pre-shoreline stabilization

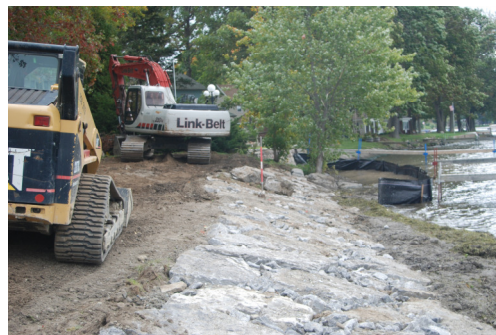
Photo 10: Post shoreline stabilization

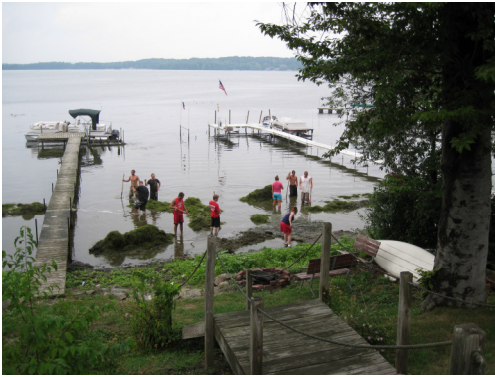
In order to support aquatic vegetation (weeds) management, annual funding is allocated to 4 of the inland lakes of Chautauqua County. These funds are to be utilized for harvesting and control of excessive growth of aquatic vegetation.

Photo 11: Shoreline weed cleanup

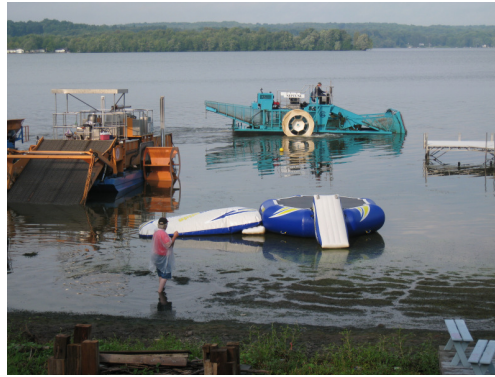
Photo 12: Mechanical weed harvesting
